A Draft Report[®] for the Pilot Demonstration of

Controlled In-Situ Chemical Oxidation Technology

Ashland/Xcel Energy Lakefront Site d.b.a Xcel Energy, a subsidiary of Xcel Energy ("NPSW")

June 1, 2007

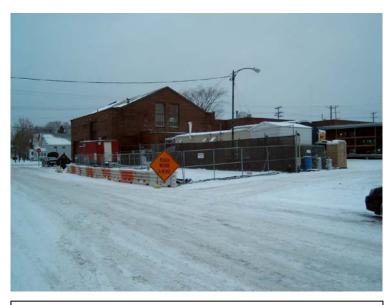
Winter arrived prior to the start of work in the MW-13 pilot area. Photo 27 above depicts the area after the exclusion zone has been established. The red decontamination trailer is visible in the background.

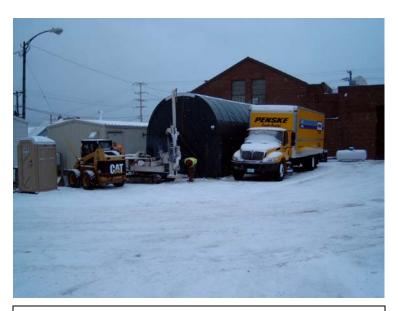
Photo 28 above shows the green shelter housing the "*Deep-Shot Rig.*" $Cool\text{-}Ox^{TM}$ reagents are secured in the truck at right. This vehicle is locked at night, as a safety feature, to prohibit vandalism or access by only the curious. The crew can be seen readying the Geoprobe ® and the Skid Steer for the days work.

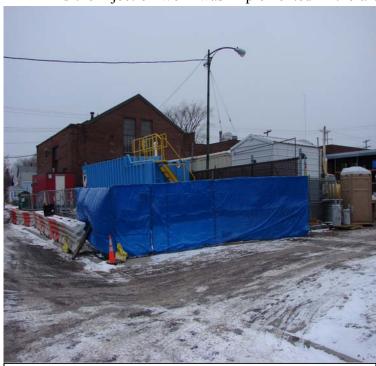
The maintenance building sheltered the work in the MW-15 pilot area from the fierce north winds off Lake Superior. However, the MW-13 area was directly exposed to the numbing cold. The blue tarps shown in Photo 29 above provided relief from the wind as well as privacy for the injection work.

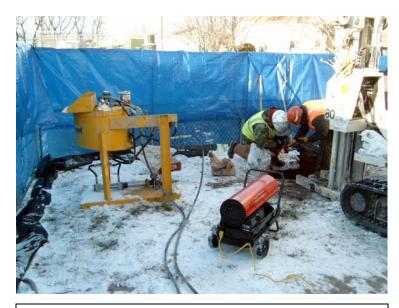
The torpedo heater in **Photo 30** above helps keep pump lines thawed and personnel to cope with the cold as they work in the vault at extraction well **E-1**.

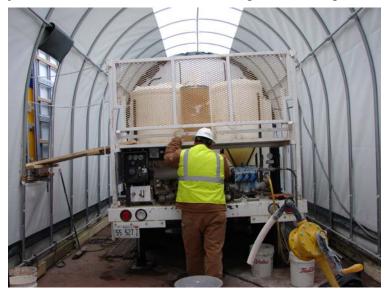
Photo 31 depicts the interior of the green shelter, employed to protect the *Deep-Shot Rig*TM from the freezing conditions outside. Propane heaters kept pumps and hoses from freezing. The ramp to truck storing the Cool-OxTM reagents can be see at the left of the photo.

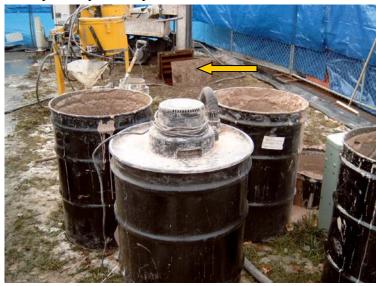
Photo 35 shows the drum vacuum employed to capture reacted contaminants and reagents that were expelled to the surface during the application process. Extraction well **E-1** can be seen in the background (see arrow).

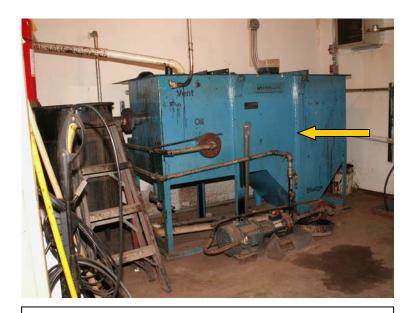
Photo 41 above shows the collector (see arrow) in the water treatment plant that is employed to separate the coal tar from the groundwater pumped here from the four extraction wells installed in the Copper Falls significant Aquifer. Although reactions occurring in extraction well **E-3**, the expected changes in the appearance and chemical characteristics of the water in the collector, either in color or the pH, did not occur. Upon investigation, it was determined that the extraction pump in E-3 was faulty. This discovery was critical to the project since fluctuations in the amount of coal tar captured in the collector was one of the parameters designed to measure the success or failure of the pilot demonstration.

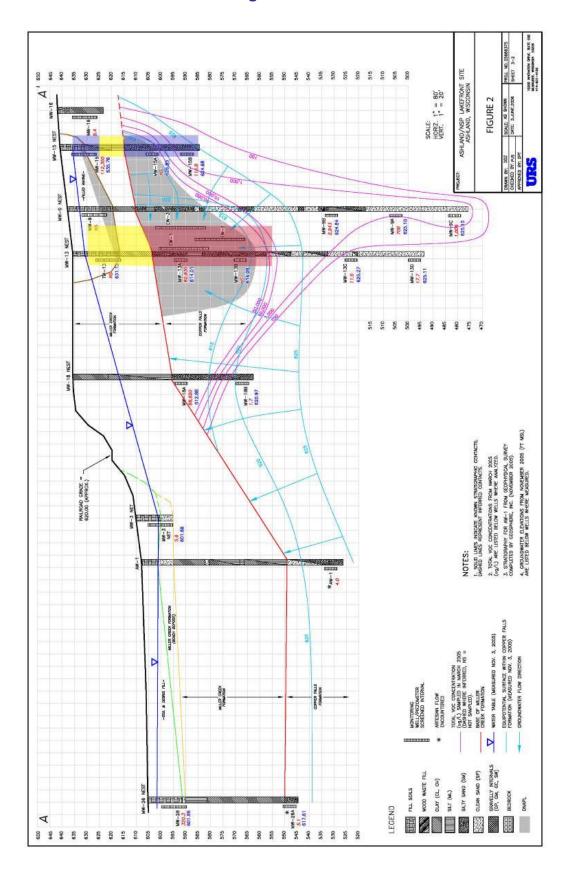
Although the entire volume of reagent was successfully injected, because of refusals encountered in the Copper Falls Aquifer due to the presence of cobbles and apparently hardpan seams, the average injection depth was sixty-three and one-half (63½) feet. **Figure 2** indicates that the depth of the contaminant plume is approximately seventy-three (73) feet. Therefore, if one calculates the vertical injection interval from thirty (30) to sixty-three and one-half (63½) feet, approximately seventy-eight percent (78%) of the volume of the plume in the treatment area was addressed.

Extraction well **E-3** is located approximately forty (40) feet across the treatment area to the south. This was an event that the TEAM had hoped to observe at extraction well E-1. Investigation of Figure 2 will reveal a considerable gradient upward at bottom of the Miller Creek Aguitard between extraction wells **E-1** and **E-3**. Reaction gases generated from the injection activities near E-1 had evidently migrated upward to extraction well E-This 3. type ofcommunication within the Copper Falls Aquifer was very welcome. It demonstrated that reaction gases could be used to

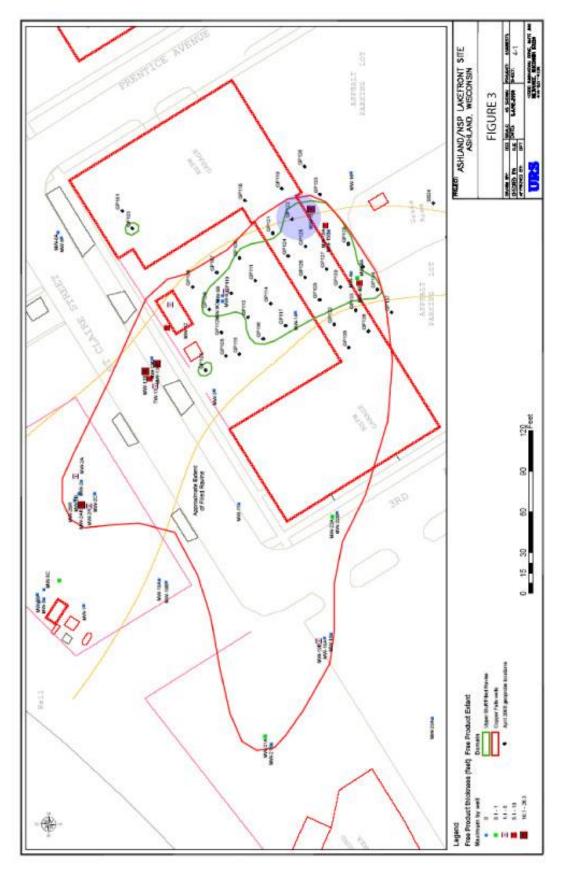
Figure 3

The results of the reactions coincide with the finding of Newfields as shown in **Figure 3**. Heavy reactions with foam and odors were noted to the west and southwest of the holder with milder reactions to the south and southeast. Only slight foam reactions

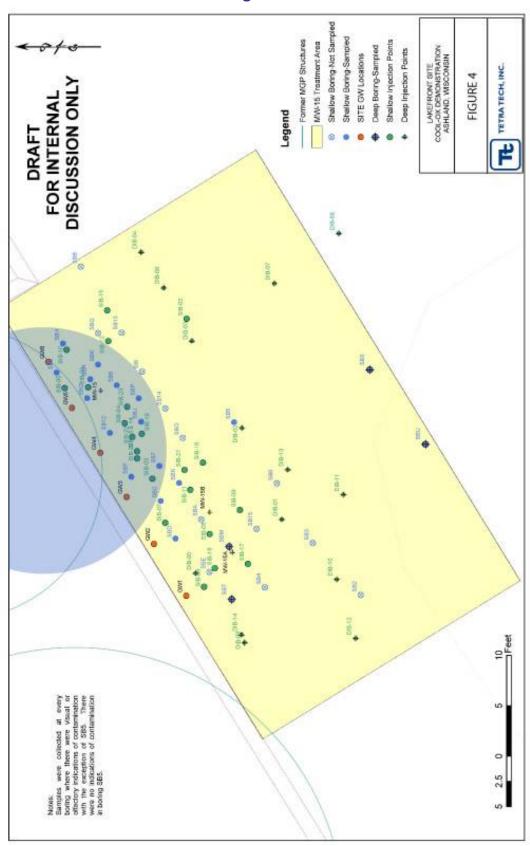
Figure 4

east to west direction, the arc of the holder began approximately two (2) feet from the "L" (by the gas service) in the maintenance building and extended westward along the wall approximately twenty-four (24) feet. Bisecting the arc, the wall extended approximately eight (8) feet from the building wall at the furtherest point. The remainder of the holder is located under the maintenance building. **Figure 4** depicts the approximate location of the holder.

As previously noted, the injection work was initiated with Deep Injection Point (**DIB-1**) (see **Figure 4**). This IP location was selected because it was believed it was far enough west to include all three (3) geologic formations (Filled Ravine, Miller Creek Aquitard and Copper Falls Aquifer). However, from the surface, the injection was indicative of penetrating very hard clay. Although the forty (40) fbgs depth was achieved and the injection completed in the Copper Fall Aquifer, retrieval of injection tooling was extremely difficult with the bottom ten feet of rod being lost. The IP was grouted from twenty-five (25) feet to the surface with Portland cement. It was the opinion of the experienced TEAM Direct Push Technology (DPT) rig operators that there was no variation in the consistency of the upper twenty-five (25) feet and that the hard clay formation of the Miller Creek Aquitard was encountered at the surface.

While the spacing of the injection points was designed on a nine and one-half (9 ½) foot matrix, the discovery of structures and utilities in the injection zone during the actual application, necessitated the redeployment of the injection points such that, they would not impact of these interferences (see **Figure 6**). Note the green dots on the figure depict the location of the designed IPs, while the black numbers connote the location of the actual IPs as they were installed. Although the remedial design called for the injection of 33,633 gallons of reagent equally into the twenty-seven (27) IPs, the combination of utility interference, refusal from debris in the Filled Ravine and the encounters with the rock and hardpan in the Copper Falls Aquifer, rendered it impossible to adhere to the original design. **Table 3** contains a breakdown of each injection point including, the depth, the volume of reagent injected, obstructions encountered, and any reactions noted.

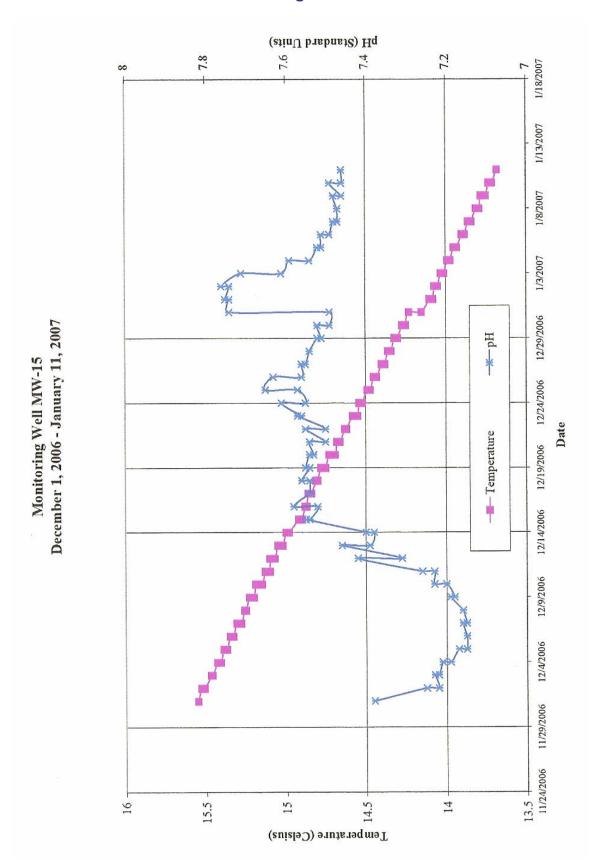
Figure 7

that is insoluble in water at the normal groundwater temperatures encountered (see Figure 7). This can only be accomplished by changing actually chemical characteristics of either the compound or the solution that is being used to dissolve or mobilize the compound. Chemically, this can be accomplished by several methods including the one used to emulsify the coal tar at this site. Other methods such as the use of surfactants can be used to increase the ability of the solvent (water) to carry the compound. The Cool-OxTM
